Parking Garage Re-done with Miracote Repair Mortar and Protective Coating

Washington Dental Service Parking Garage –
Top Deck Restoration and Waterproofing –
Seattle, WA

Project Contractor: Construction Solutions and Services
Inc. – Kenmore, WA

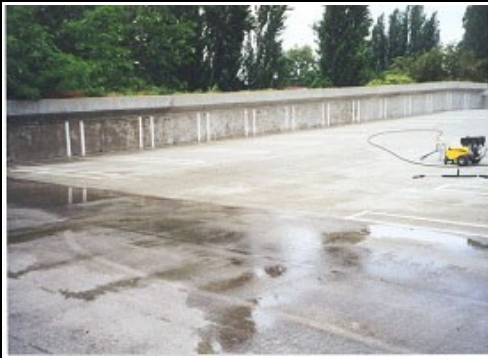
1. The first part of the project was pre-paring the surfaces. This included removing and storing for future reinstallation all of the pre-cast parking bumpers, then pressure washing the entire top deck.

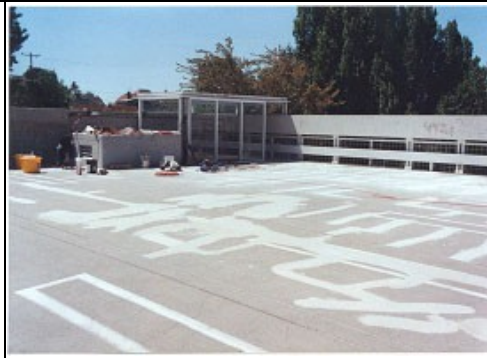
2. The next step required repairing all cracks larger than 1/16 inch with Miracote Protective Coating and imbedded fiberglass tape.

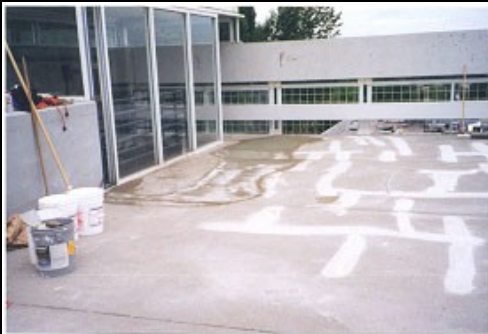
3. The low spots in the flat areas of the deck were then filled with Miracote Repair Mortar to eliminate ponding.

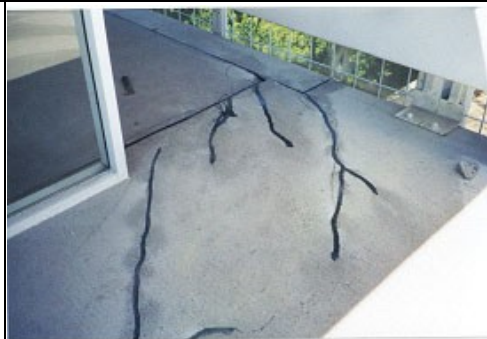
4. The largest cracks that appeared to be working and leaking directly through the topping slab and "T" slab were routed out with a crack chaser and filled with a pliable sealant.

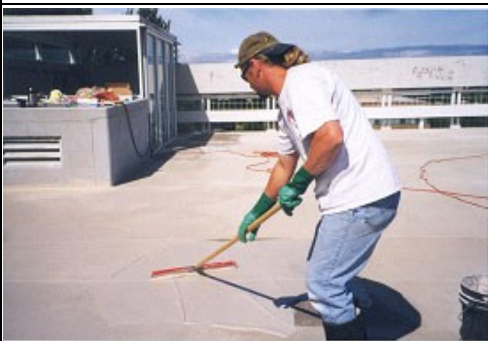
5. Next, the process of applying the first "scratch" coat of Miracote Protective Coating to smooth and fill surface voids.

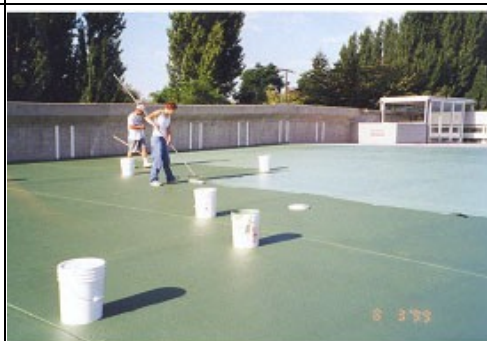
6. Followed by applying 3 coats of Miracote Membrane A.

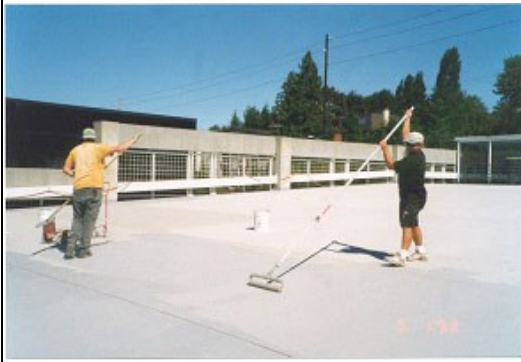
7. The membrane was then covered with three coats of Regular Miracote Protective Coating.

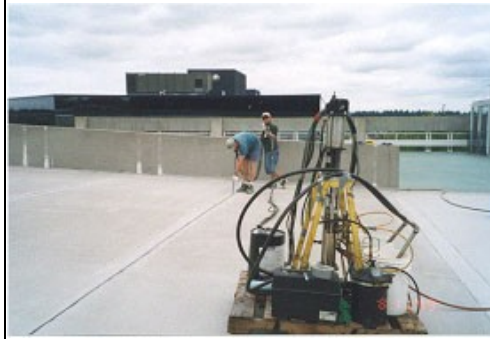
8. Then the expansion joints were filled with a two-component polyurea sealant designed to remain flexible under the vibrations of traffic loadings.

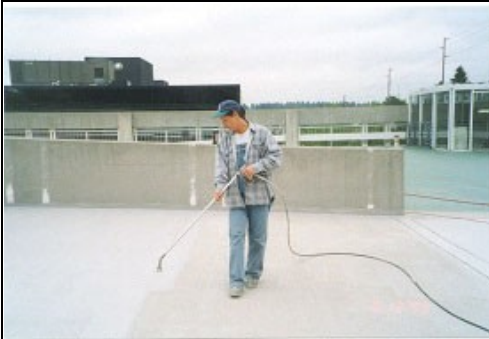
9. The final step in the system was the application of two coats of Miracote Colorbond Sealer. This can also be followed by an application of Miraseal.

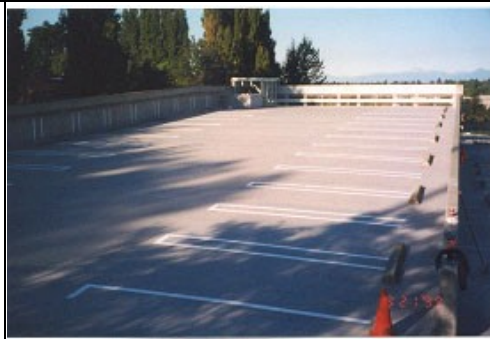
10. You can paint lines, words, etc. using any of Miracote's 15 standard. Miracote's entire system of waterproof membrane, protective coating and topcoat sealers can provide you with long-lasting protection and a readily cleanable surface.
